Final Report  
2007 Biota Monitoring  
Moab, Utah

February 2008

U.S. Department  
of Energy

**Office of Environmental Management**

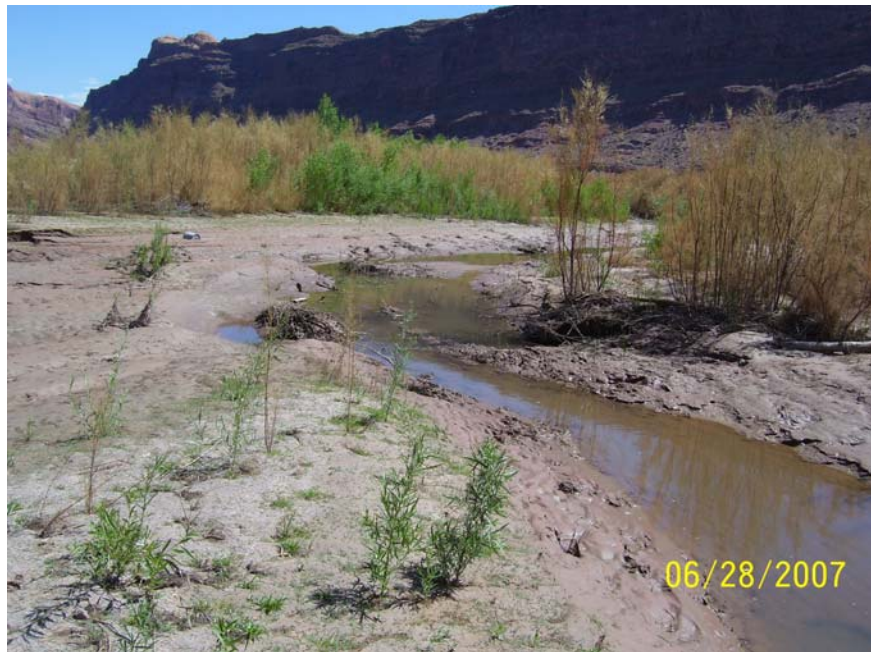
Photo 1. Looking south from the backwater channel adjacent to Configuration 3. On this day, the backwater channel was connected to the river channel by approximately two inches of water.

Biota monitoring commenced on June 28, 2007, when the river flow dropped to 6,790 cfs (see Photos 1 through 6). At this time, the main backwater channel that flows from Configuration 3 through Configuration 4 was connected to the main river channel both in up and downstream directions. In the vicinity of Configuration 3, the channel was barely connected upriver by a few inches of water; therefore, this portion of the channel was considered a habitat area (see Photo 2). Abundant wood debris, algal growth, and isolated deep-water pockets containing small fish (1 to 2 centimeters (cm)) were observed.

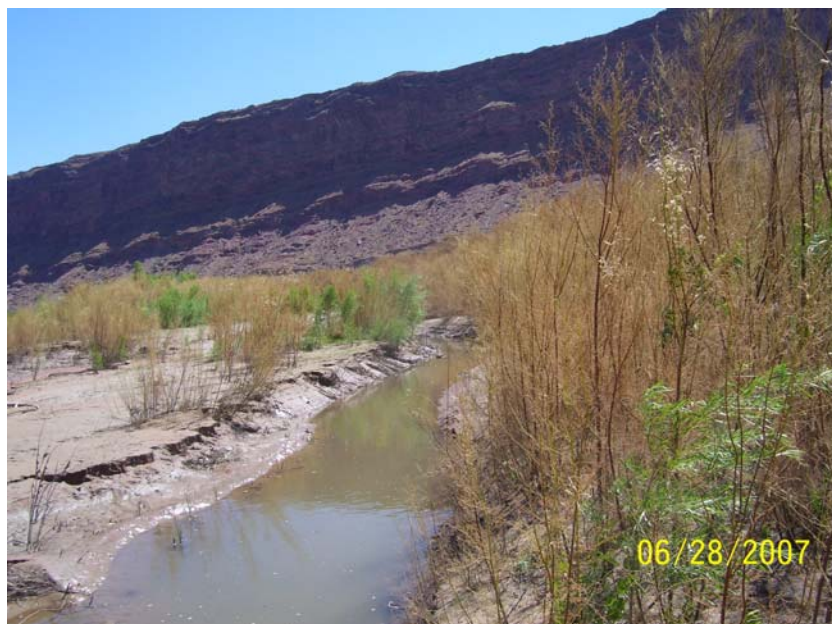
Photo 2. Looking further south down Configuration 3 backwater channel. The water was approximately three to six inches deep.

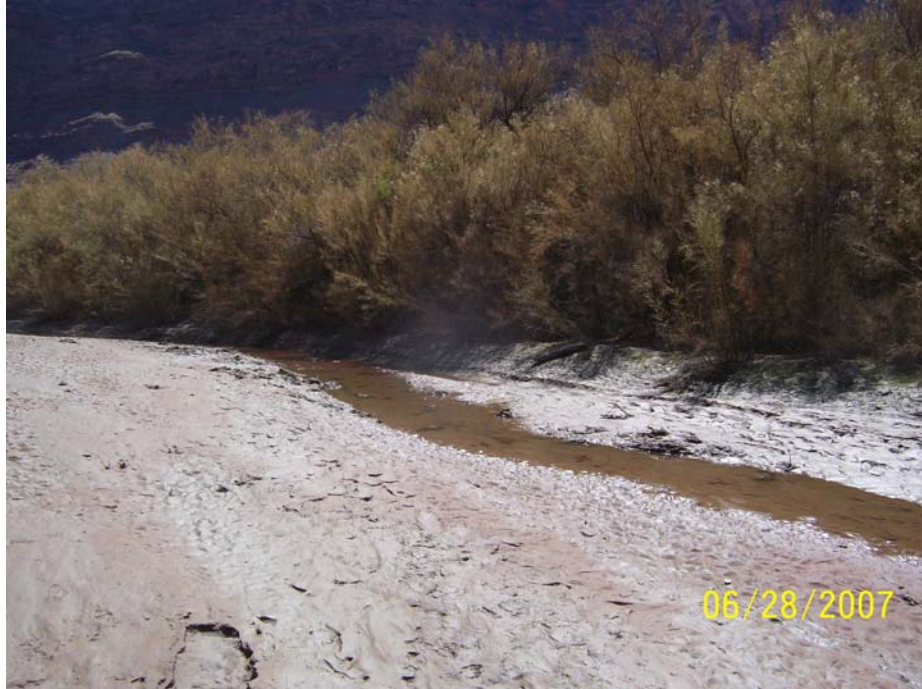
Photo 3. The backwater channel between Configurations 2 and 3.

The main backwater channel was broad and shallow adjacent to Configuration 2, and numerous schools of fish (1 to 3 cm) were observed (see Photos 3 and 4). Adjacent to Configurations 1 and 4, the main backwater channel had a higher flow velocity and was connected to the main river channel both up and downriver (see Photos 5 and 6). A few fish were observed in this portion of the channel.

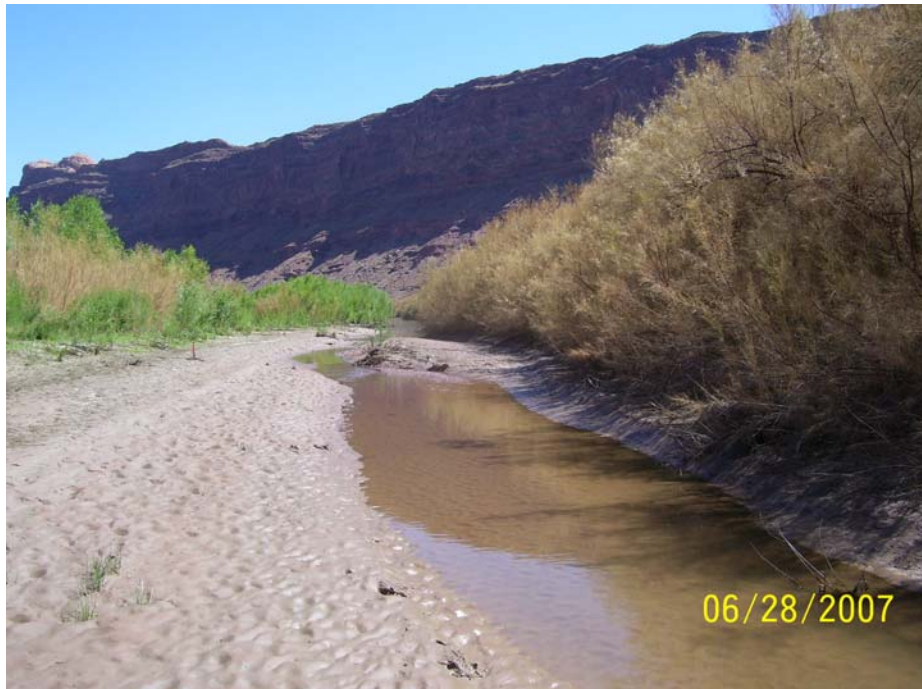
Photo 4. The backwater channel through Configuration 2.  
Abundant fish were observed in this portion of the backwater channel.

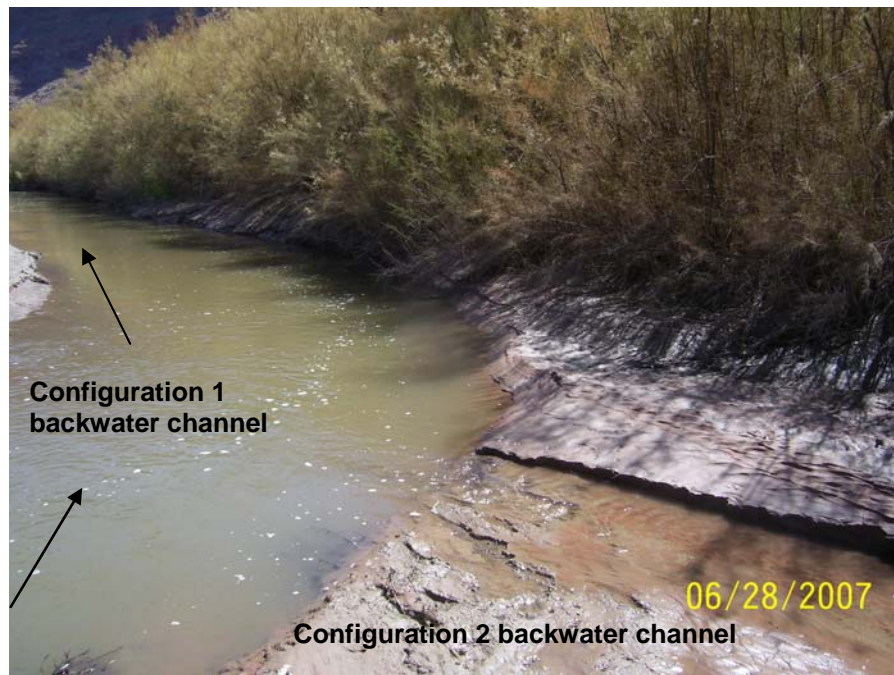
Photo 5. The confluence of the backwater channel from Configuration 2 to Configuration 1. View is to the south.

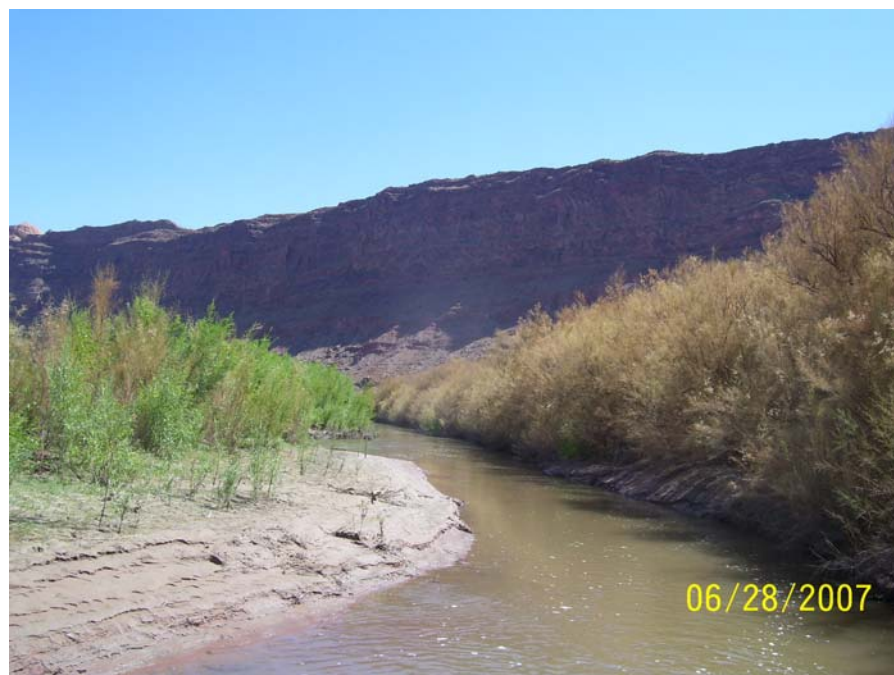
Photo 6. Looking south at the backwater channel through Configuration 1. At this time, the channel was open to the river both up and downstream.

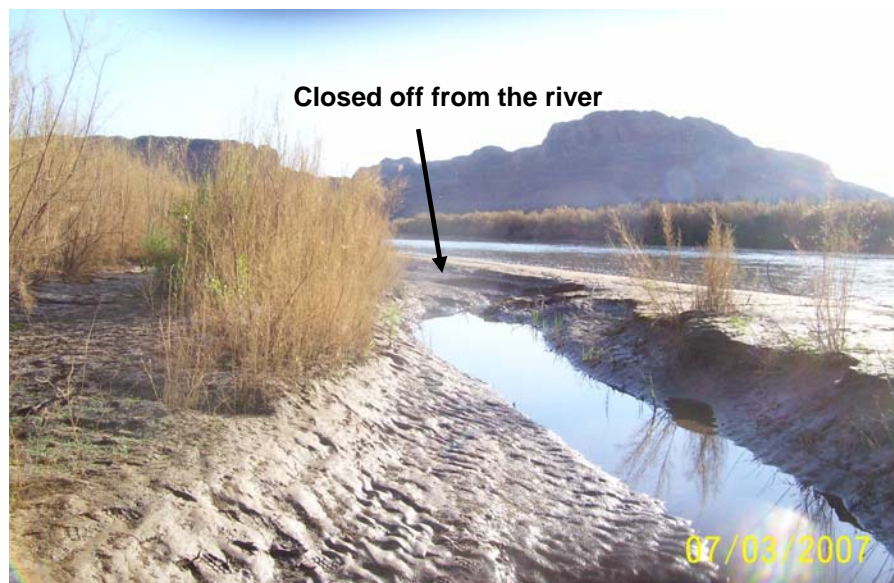
Photo 7. The backwater channel at Configuration 3 is now closed off from the main river channel.

On July 3, the Colorado River flow near the site had dropped to 5,150 cfs (see Photos 7 through 10 and Figure 3). At this time, the backwater channel adjacent to Configurations 3 and 2 was closed off from the river and consisted of isolated pockets of water. The southern most portion of the Configuration 2 backwater channel was connected to the Configuration 1 portion of the channel by a temporary channel one to two inches deep (see Photo 10). No fish were observed in the backwaters adjacent to Configuration 2.

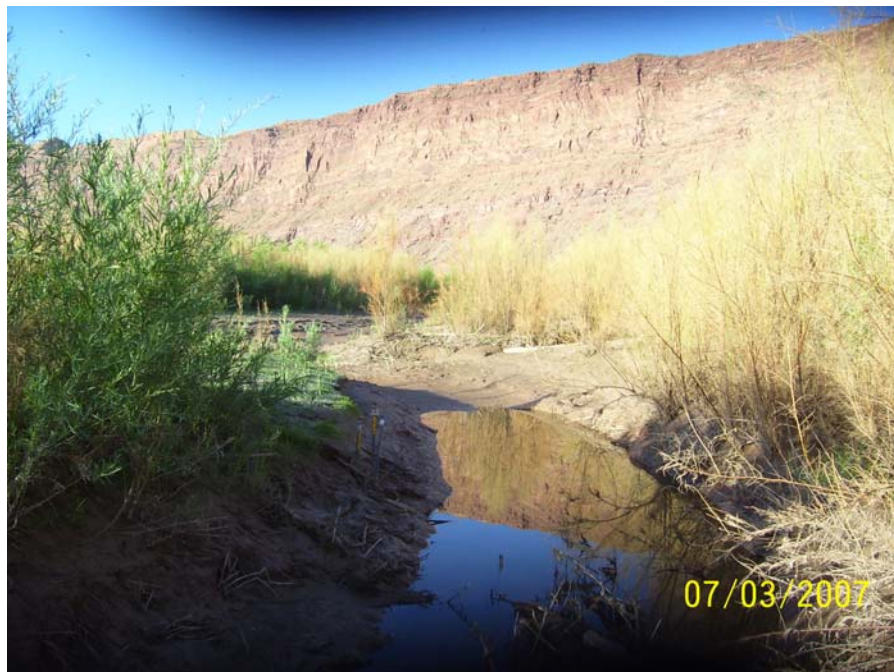
Photo 8. Looking further south from photo 5. This isolated pool of water was located near Configuration 3. Fish were not observed in this location.

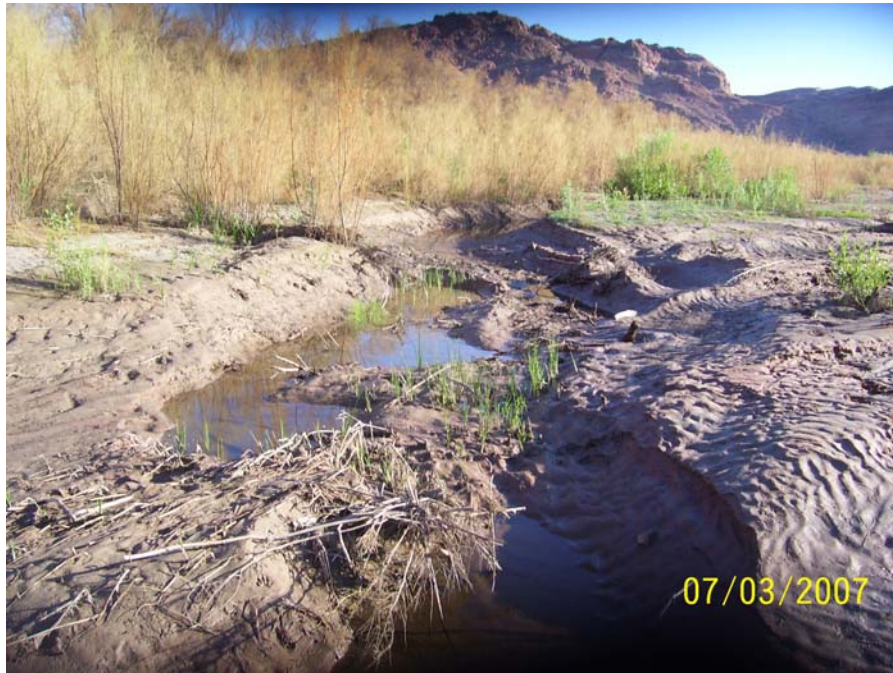
Photo 9. Isolated pool of water in between Configurations 2 and 3.  
View is to the north.

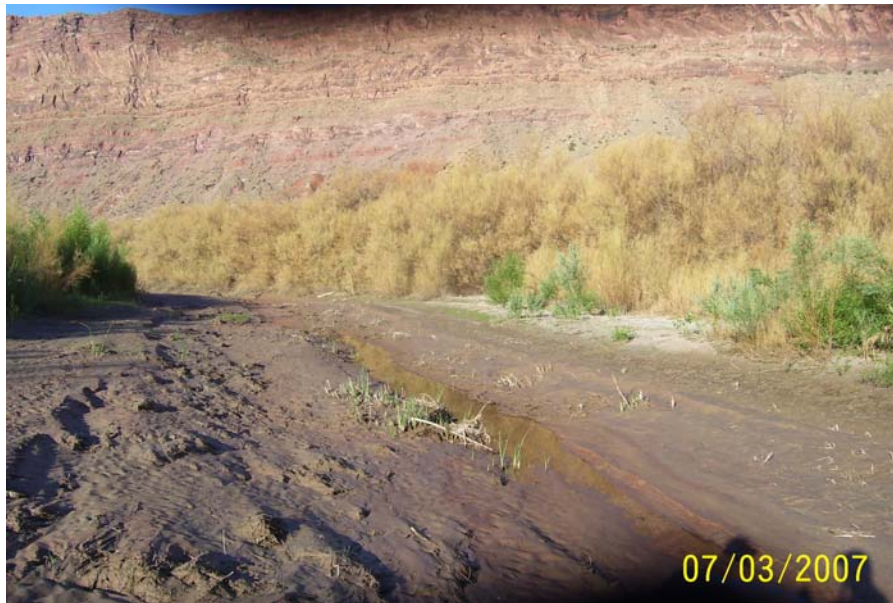
Photo 10. The backwater area of Configuration 2 is nearly dry.

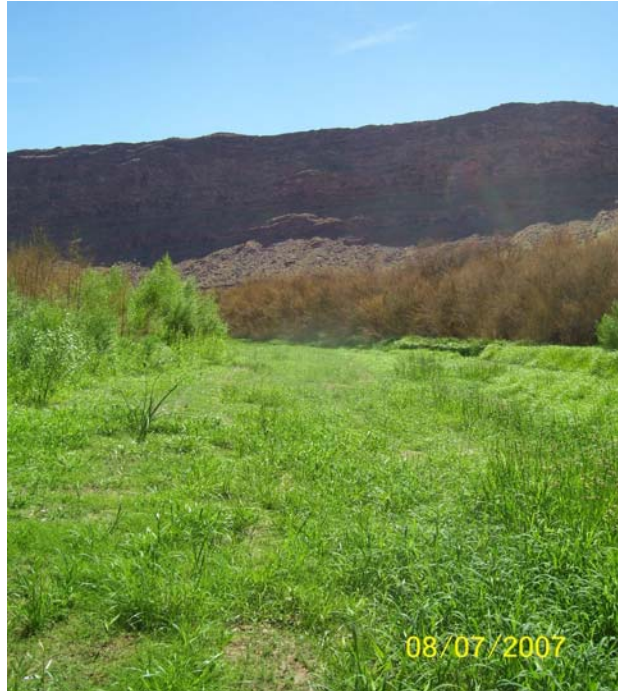
Photo 11. Looking south at the Configuration 2 backwater channel. It has been dry long enough to establish dense seasonal vegetation.

Throughout the month of August, Colorado River flow near the site ranged from 2,960 to 5,560 cfs (see Figure 4). The backwater channel adjacent to Configurations 2 and 3 remained dry and full of seasonal vegetation (see Photos 11 to 13). On August 2, the Colorado River flow dropped to 3,260 cfs (see Figure 4) and, as a result, the backwater channel through Configuration 1 was nearly dry, and Configuration 4 was a habitat area. Configuration 1 was also dry on August 22, when the flow was 3,260 cfs (see Photo 14).

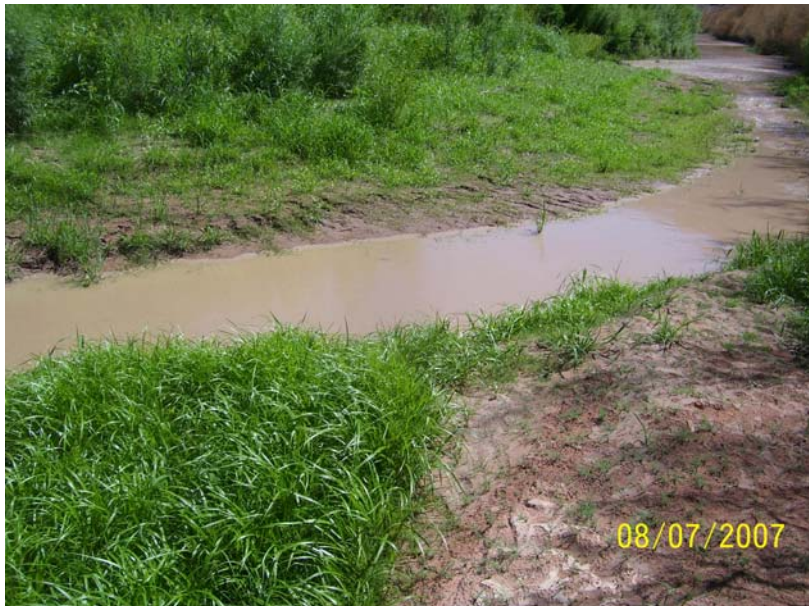
Photo 12. Backwater channel adjacent to Configuration 1. The channel is fairly narrow, but is connected both up and downstream. View is to the south.

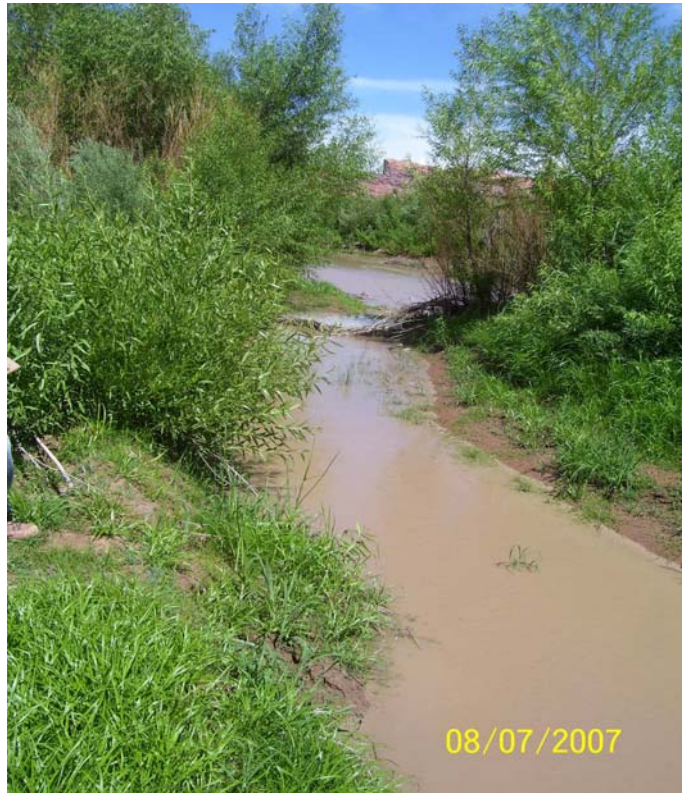
Photo 13. Backwater channel adjacent to Configuration 4.  
The water is very turbid. View is to the northeast.

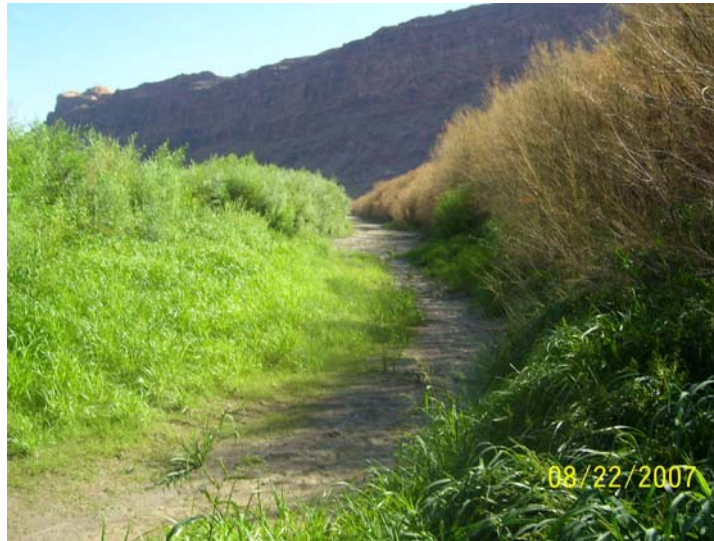
Photo 14. The backwater channel at Configuration 1 is dry.  
View is to the south.

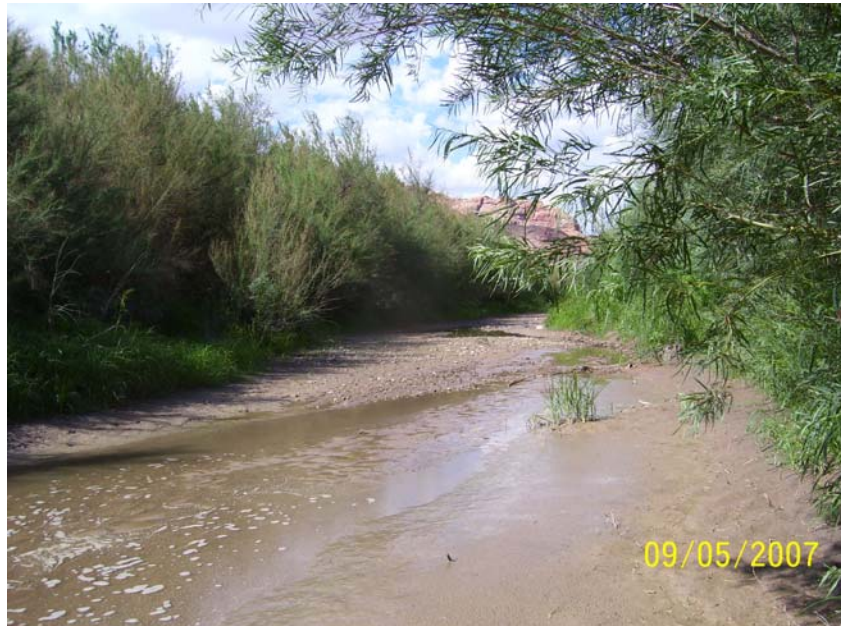
Photo 17. The Configuration 4 backwater channel is closed off to the main river channel upstream. View is to the northeast.

On September 5, the river flow had dropped to 3,300 cfs (see Photos 17 and 18 and Figure 5), and the same backwater channel adjacent to Configuration 4 was closed to the main river channel in the upstream direction. Abundant fish were observed within the channel on September 5. Location 0274 was sampled on September 4 and 5 in order to compare analyte concentrations and ammonia for the two channel conditions. Analyte concentrations were slightly higher and the ammonia concentration nearly doubled (0.11 to 0.20 mg/L) when the backwater channel was not connected on the upstream side (see Attachment A).

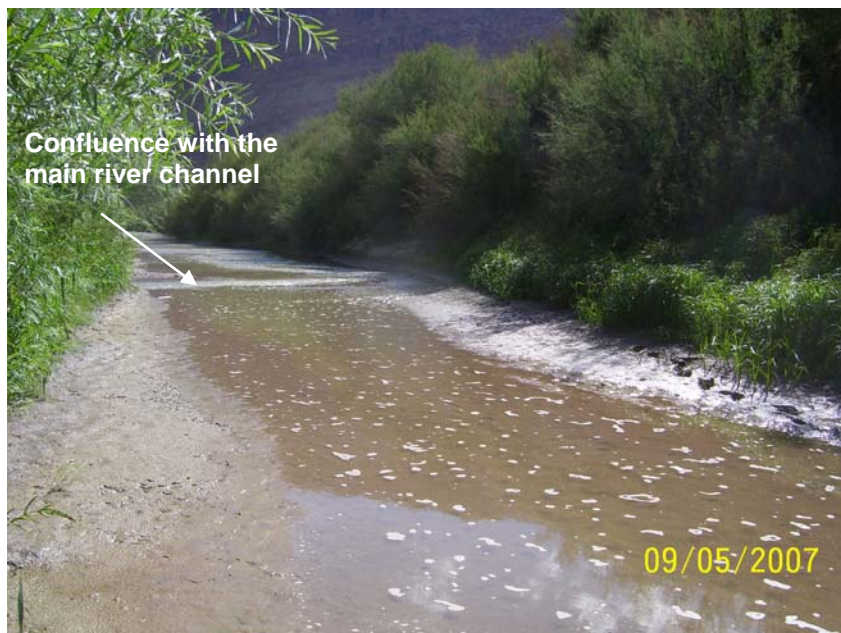
Photo 18. The Configuration 4 backwater channel is open to the river channel downstream.
